CAVE CREEK DRAINAGE MASTER PLAN

January 2008

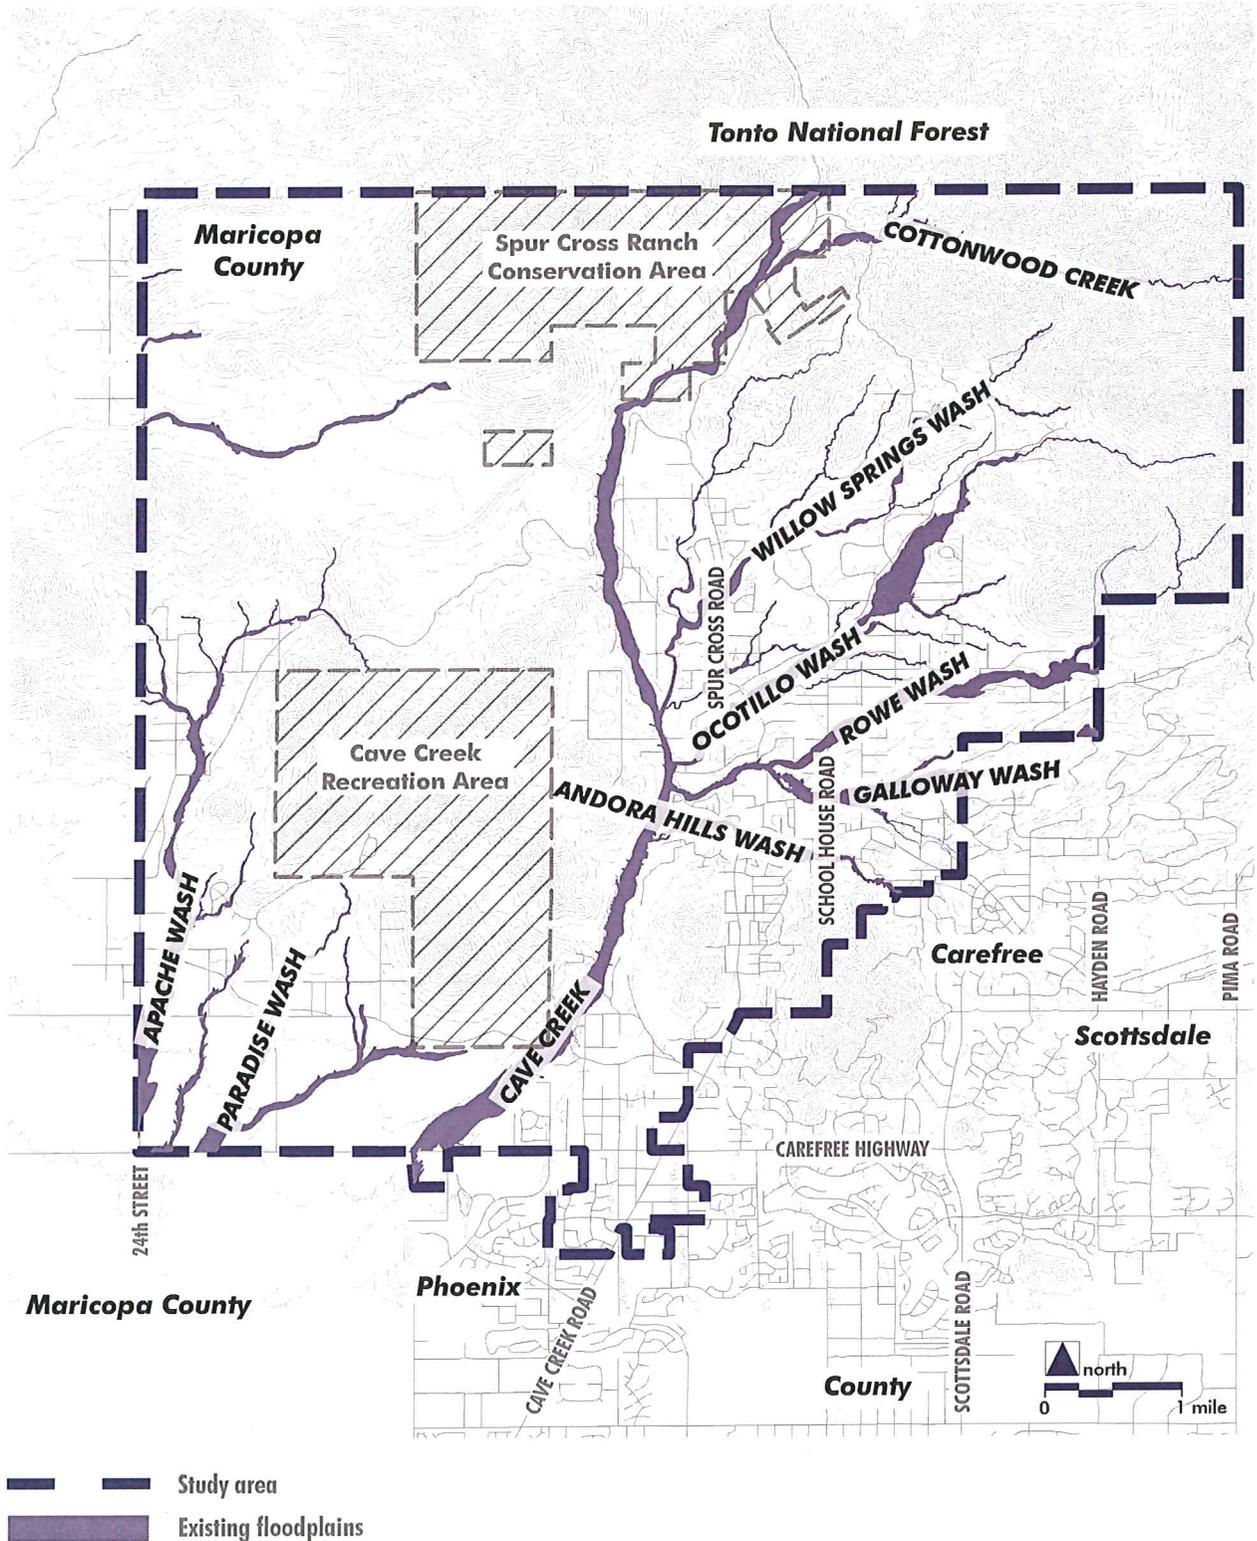
Figure 3. Major washes in the study area

There are several major washes transecting the study area, including Cave Creek, Willow Springs Wash, Ocotillo Wash, Rowe Wash, and Galloway Wash as shown in *Figure 3* on page 5. Approximately 90 linear miles of watercourses were considered for delineation in the preparation of the DMP.

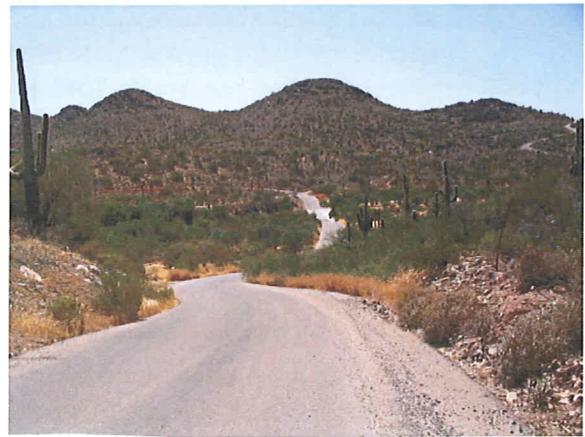
A typical Town wash

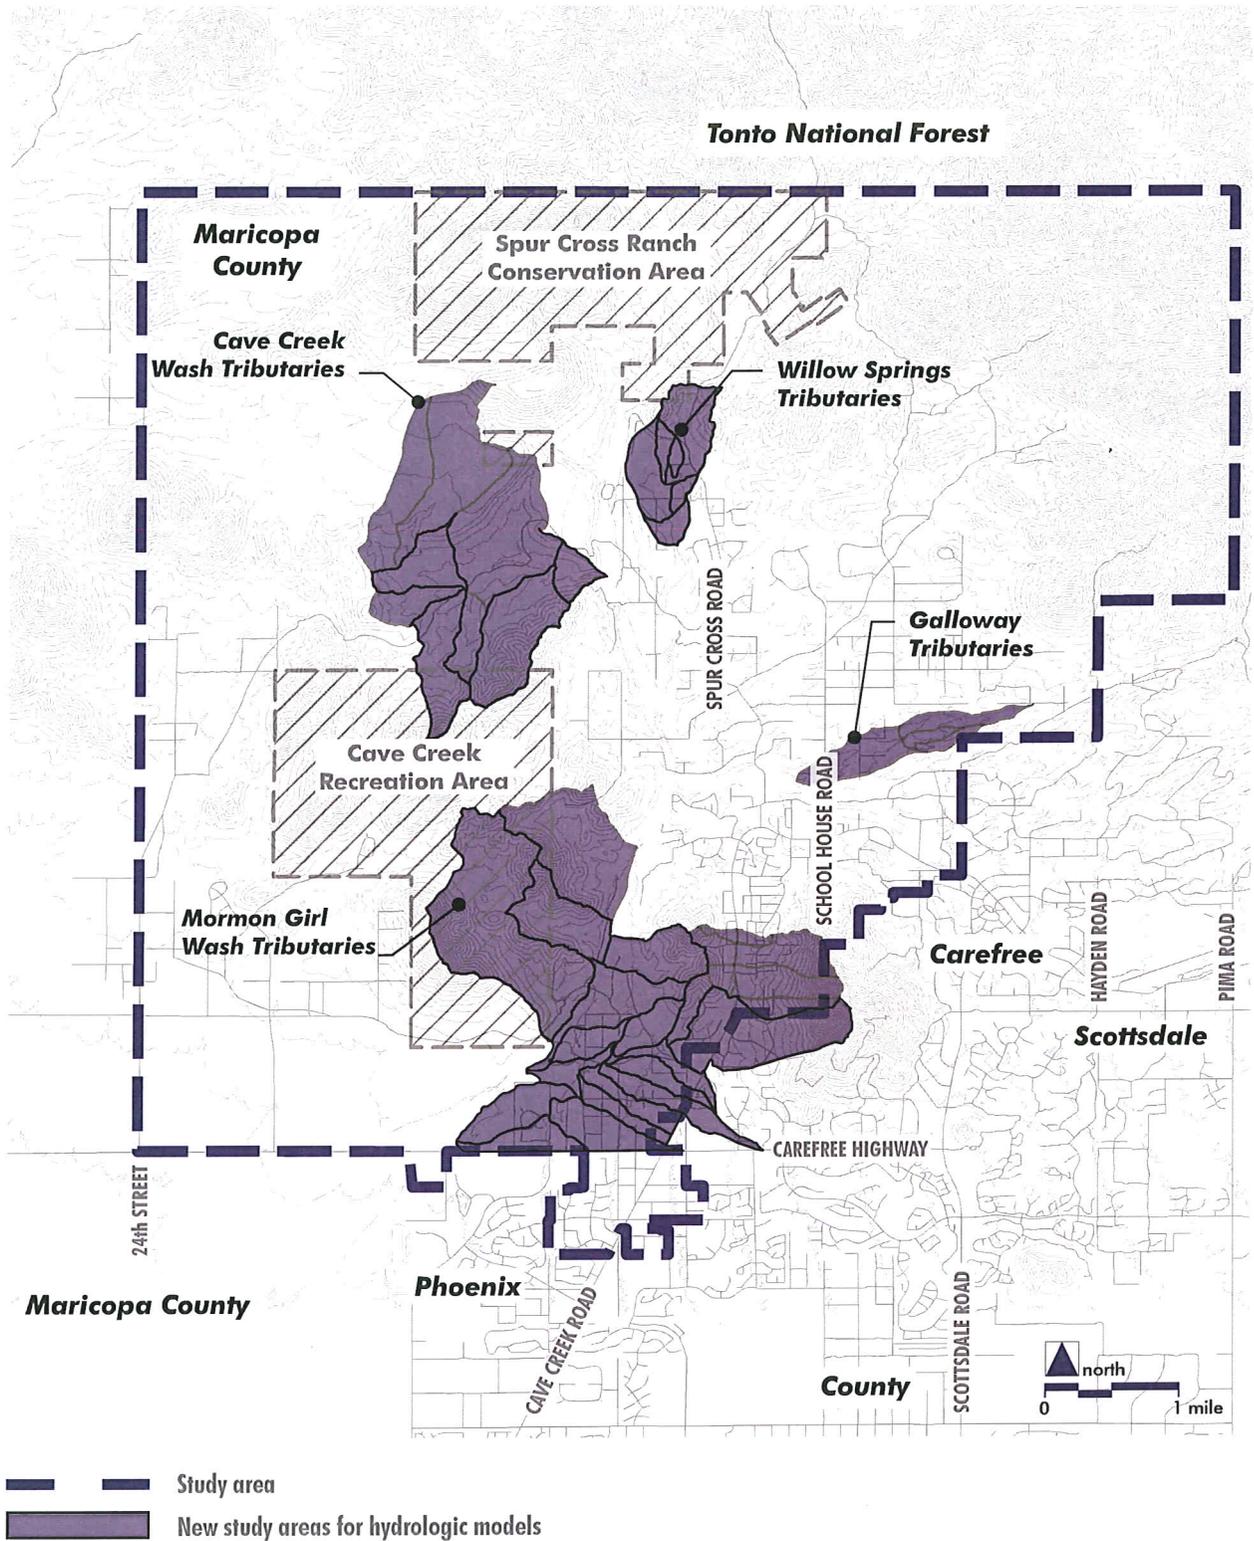
Figure 5. Location of new hydrologic models

HEC-1 modeling was developed for existing and future conditions using rainfall depths for a 6- and 24-hour duration for the 100-year, 50-year, 10-year, and 2-year events. The rainfall distribution type is the SCS Type II distribution for the 100-year 24-hour event, and Maricopa County Pattern storms for the 6-hour duration events. HEC-1 rainfall losses were estimated using the Green and Ampt infiltration equation option. The Phoenix Mountain and Desert/Rangeland S-graphs, as defined in the DDMMC were used to generate hydrographs. The normal depth storage routing routine was used for all channel reaches. Representative 8-point cross sections were generated.

Concentration points were included at the limits of the study, at significant tributaries, and at road crossings or culverts. Additional consideration was given to the washes subject to future floodplain mapping under Phase II of this project. Sheet 15 in Appendix F of the study prepared by JE Fuller as part of Phase I analysis has been updated by HDR and depicts the Recommended Phase II Delineations of this report.

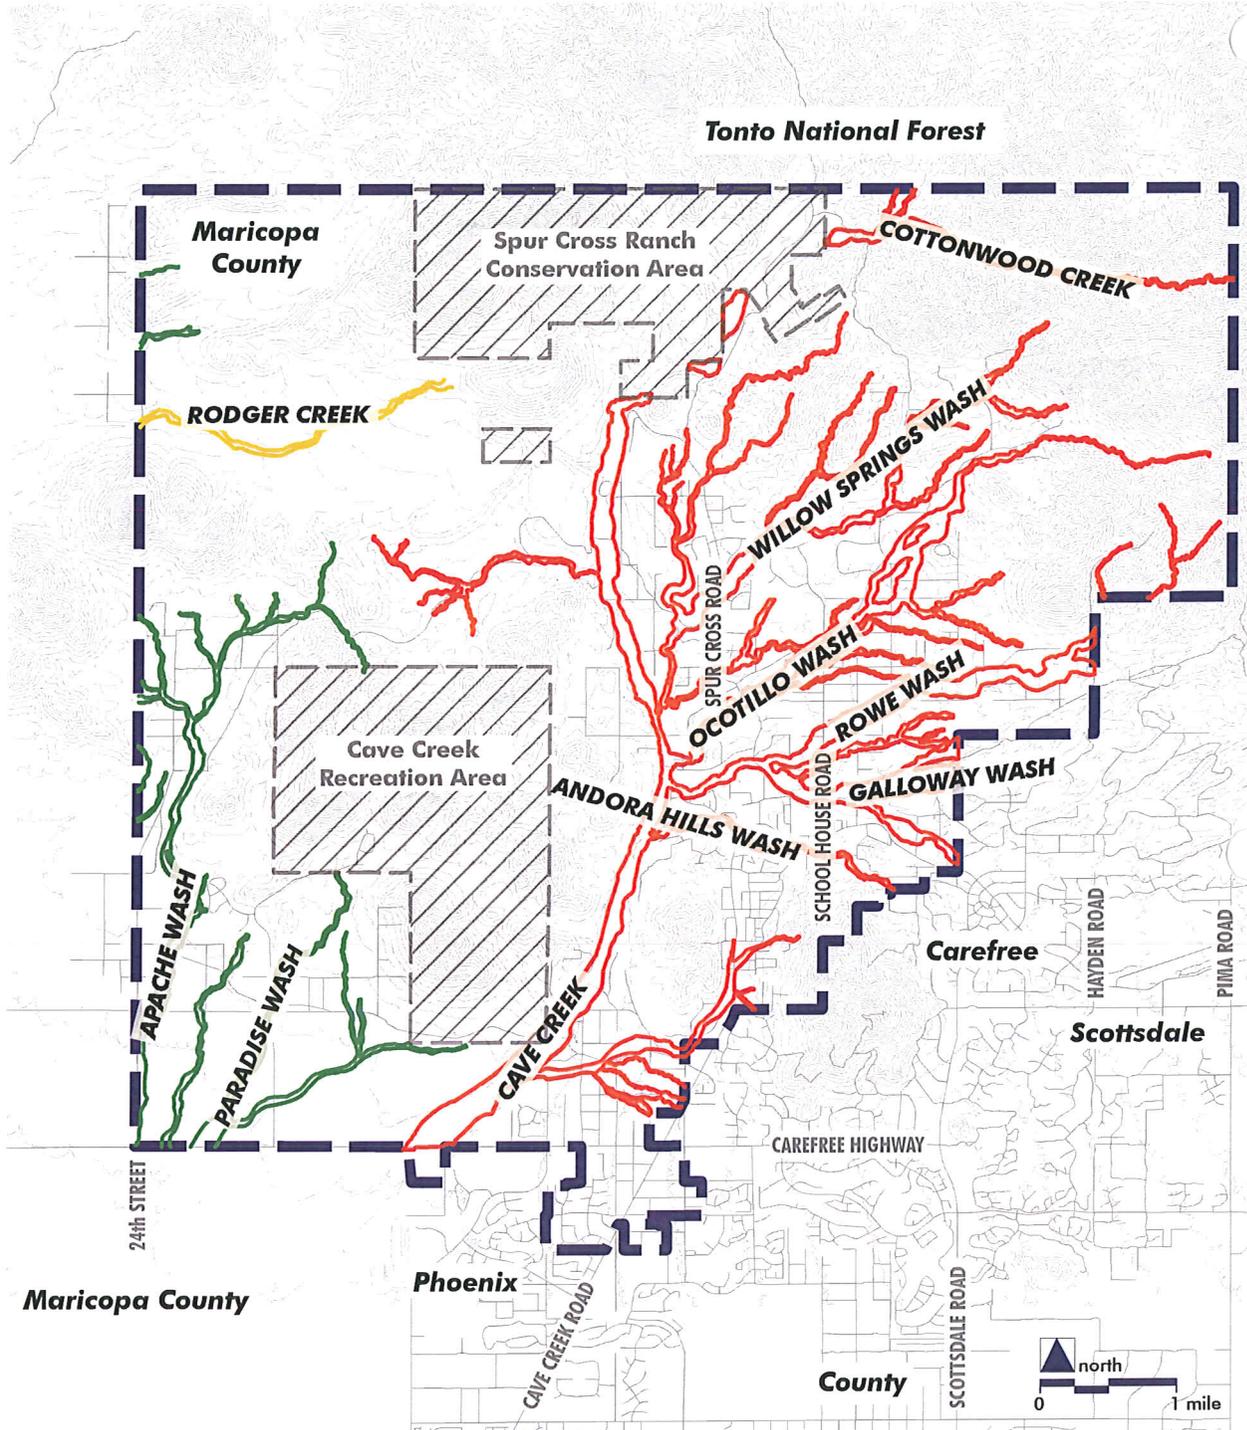
Figure 6. Erosion hazard setbacks

The recommended EHZs shown on the next page in *Figure 6* are intended to identify the areas likely impacted by future lateral erosion, or the areas for which more detailed analysis is warranted prior to future development. The EHZs from the Adobe ADMP (JEF, 2004) and Rodger Creek EHZ (JEF, 2001b) studies are also included on the maps. All of the recommended EHZs are based on the engineering judgement and experience of the project engineer/geomorphologist, and therefore cannot be reduced to a single formula or series of equations. In general, the recommended EHZs are conservative. *Figure 6* on page 24 is intended for illustrative purposes only. The EHZ boundaries are also provided in digital format for incorporation into the District's and Town's GIS systems. It is anticipated that the GIS data will be used by Town staff in the evaluation of future building permits.

The recommended best management practice for the EHZs is to prohibit construction of permanent or habitable structures within any delineated EHZ. If development is to occur within established EHZs, a detailed analysis is recommended as part of the design process.

The purpose of an erosion hazard zone (EHZ) is to provide the floodplain manager a tool to identify areas that have the potential to be adversely impacted by channel migration and/or changes in channel geometry. The EHZs delineated for the Cave Creek DMP were based on field observations, comparison of historical and recent aerials, the SS 5-96 Level 1 and Level 2, and the equilibrium slope analyses. It is possible that with more detailed, site-specific analysis, the EHZ delineations could be refined in some locations. It should be noted that more detailed, site-specific investigations may still reveal the need for engineered erosion protection measures in order for construction of proposed facilities to be approved by the Town within a delineated EHZ.

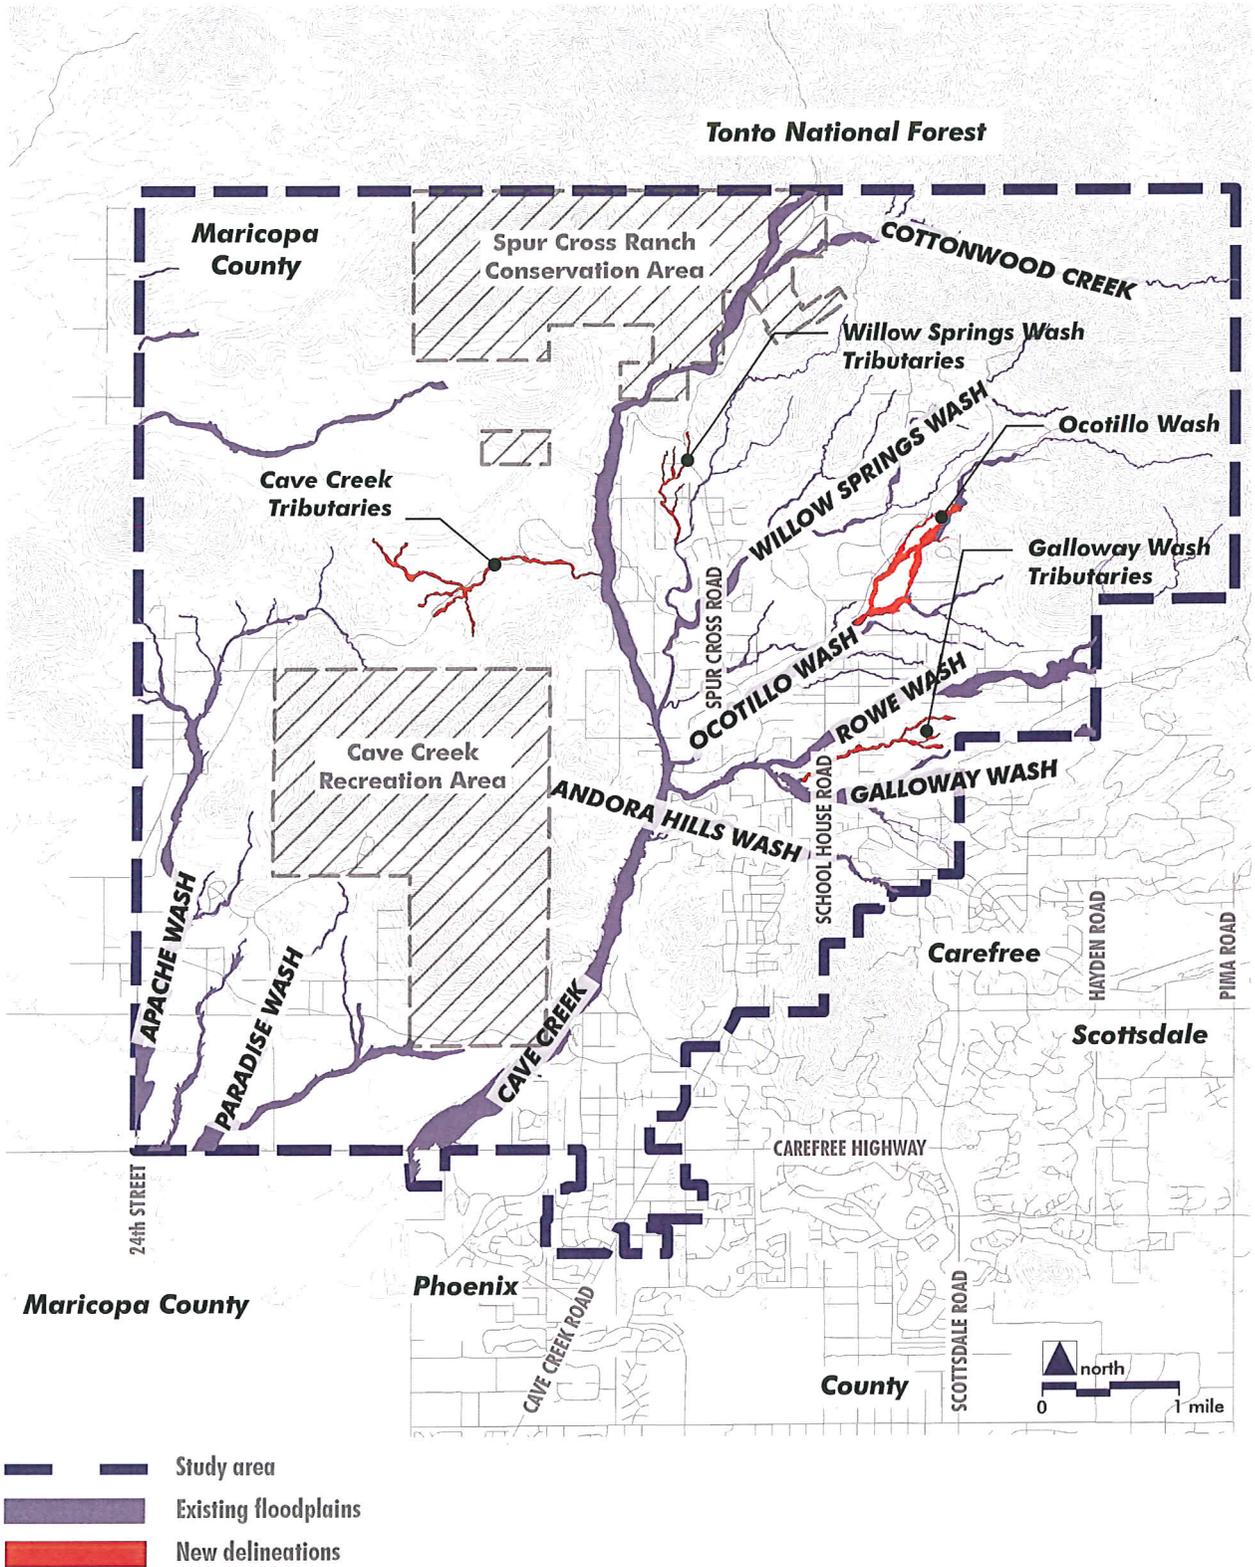
Figure 8. *New delineations*

As part of the scope of work for this project, several additional wash floodplains and floodways were delineated for the detailed 100-year floodplain (*Figure 8*, on page 29). They included Ocotillo Wash, Cave Creek tributaries, Galloway Wash tributaries, and Willow Springs Wash tributaries. The previous delineation showed only Zone A or no zone label. The new delineations show zones A, AE, or X.

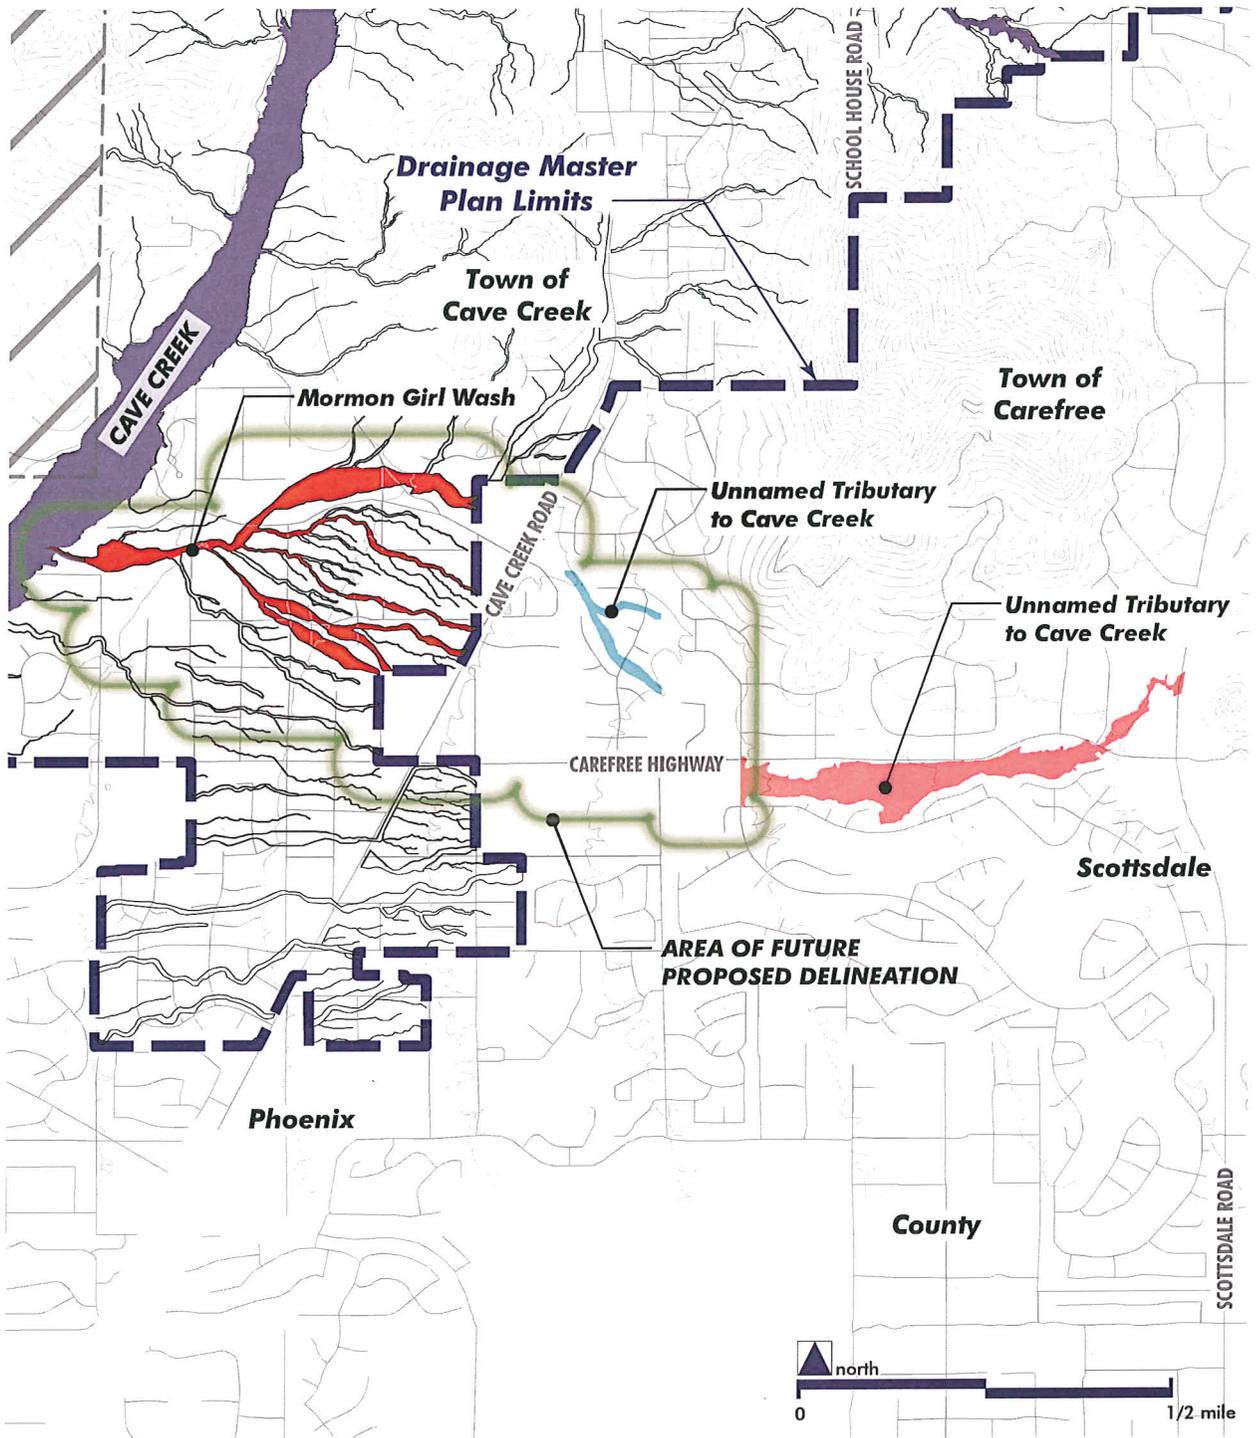
Figure 9. Area of recommended mapping for Unnamed Central Tributary

A portion of the project area contains a wash which is subject to variable flow conditions resulting from an upstream flow split condition. The wash, designated the Unnamed Central Tributary to Cave Creek (UCT), splits into two tributaries near Carefree Highway and Terravita Way in the Town of Carefree. The northern branch flows through the Town of Carefree and crosses Cave Creek Road between New River Road and Canyon Ridge Drive. Historically, this branch of the wash has been called “Mormon Girl Wash”, and flows through the Town of Cave Creek north of New River Road and eventually discharges into Cave Creek. The southern branch of the UCT crosses Cave Creek Road approximately 1,000 feet north of Carefree Highway and rejoins the north branch near the intersection of 50th Street and New River Road.

Considerations must be given to both the upstream and downstream properties when designing improvements. It appears that the flows in the UCT/Mormon Girl Wash system have been poorly understood in the past, before detailed studies were commissioned on the area in the early 2000s. It is unknown what flows were used when designing the residential development along the wash that pre-dates the detailed studies. As part of the Cave Creek Drainage Master Plan report prepared as part of this project, a recommendation exists for mapping the floodplain generated from this wash. The

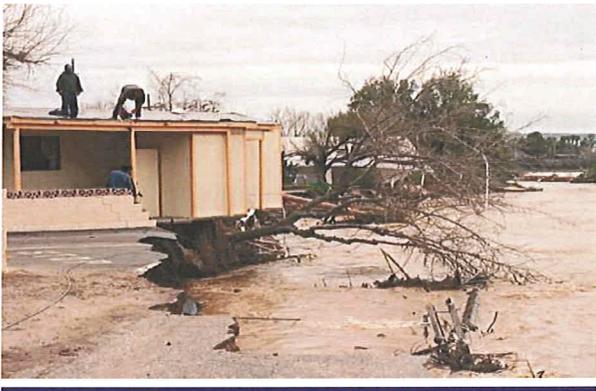
Sever erosion damage

Erosion hazard setback limits (EHSL) are areas adjacent to or within major washes where the placement of structures is prohibited due to the potential for instability. These limits are established to protect structures from erosion-related damages. Existing structures determined to be inside the EHSL should be protected by structural erosion control measures. Examples of structural erosion control measures include loose or grouted riprap, retaining walls, gravity walls, roller compacted concrete, etc. General design guidelines for erosion control structures are found in the *Drainage Design Guidelines* prepared for the Town of Cave Creek.

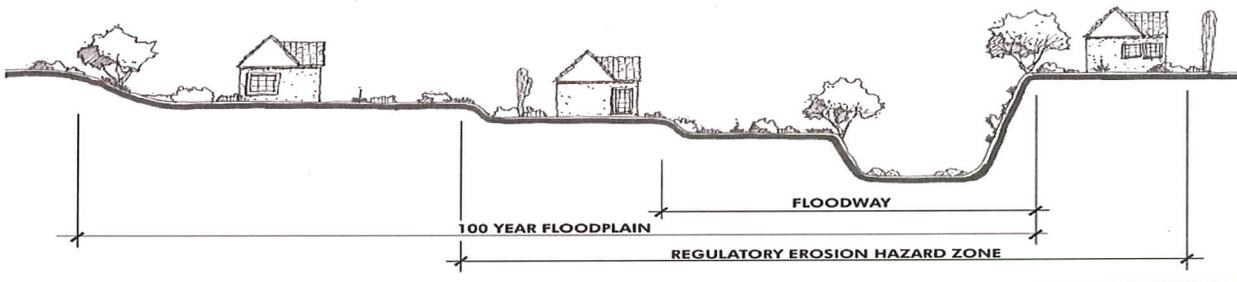
Erosion hazard setback limits can be beyond what appears to be the edge of the wash

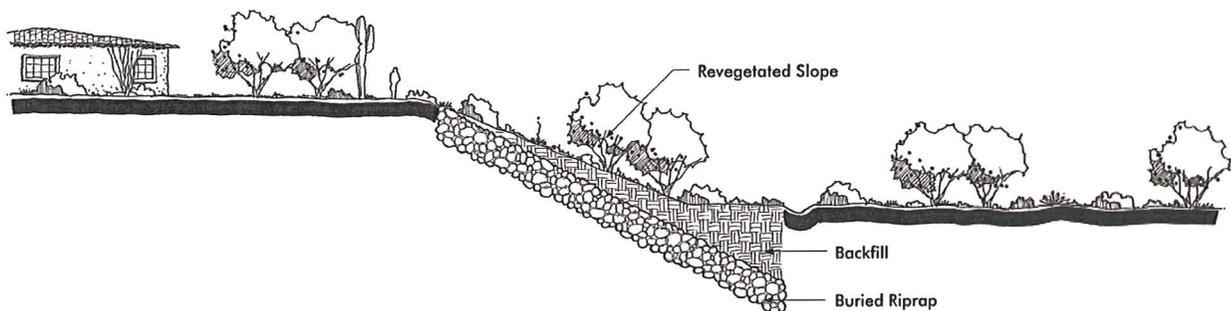
Buried riprap, a structural erosion control measure, can be concealed with backfill and desert plants

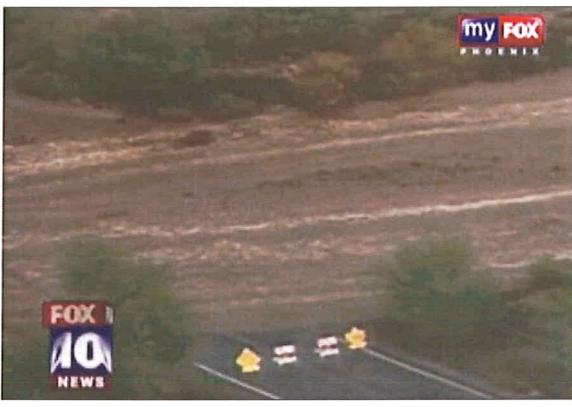
Galloway Wash at School House Road, July 23, 2007

Most of the wash crossings in the Town are “at-grade” crossings; meaning they allow water flowing in the wash to pass over the roadway. This is true for wash crossings on both publicly-owned and privately-owned land.

At-grade crossings are effective in the Town due to the low, initial expense and their ability to function during dry periods, which are most days of the year. Those infrequent occasions when washes are flowing, they should not be crossed due to the hazards of becoming stranded or swept downstream.

Most vehicles attempting to cross the road will lose grip in less than 6 inches of flowing water, and most vehicles can become buoyant in 2 feet of water or less. Nearly half of flash flood fatalities are automobile related. The State of Arizona has instituted the “stupid motorist law” (Arizona Revised Statutes Section 28-910) — individuals who become trapped after driving around barricades or failing to observe posted warnings could be held liable for the cost of their own rescue, as well as the potential additional fines.

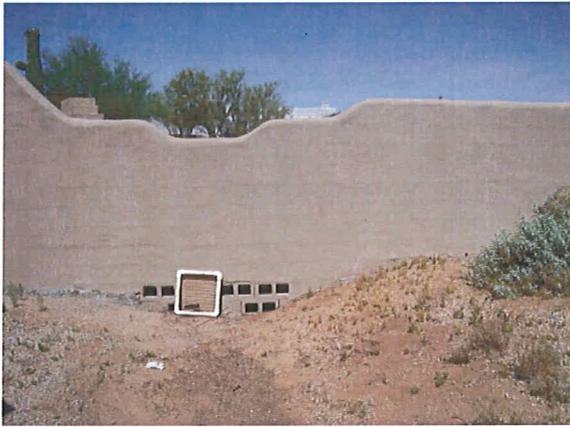
Small drainage openings will restrict natural flows.

No property wall shall be constructed as to prevent the discharge from the 100-year storm event through any parcel within the Town. Any property walls constructed within or across a wash shall utilize a system to provide adequate conveyance of water. Additionally, all walls are subject to approval by the Town Engineer and should be constructed under permit from the Town of Cave Creek.

If a wall was not constructed under permit and is found to inhibit drainage, the owner may be required to remove or alter the wall. Additionally, sub-standard or blocked openings i.e. openings that may restrict location, volume, velocity, sediment yield, or direction of flow; or that have been blocked, may require reconstruction at the expense of the property owner.

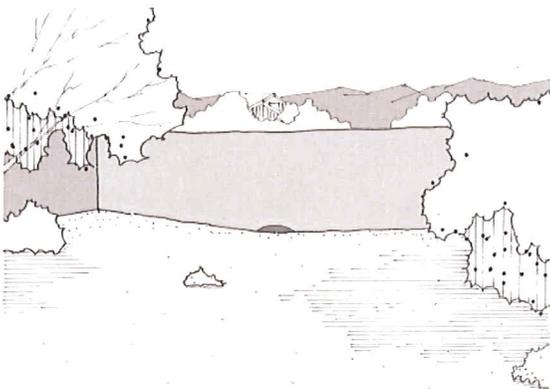
A wall shown with improper openings.

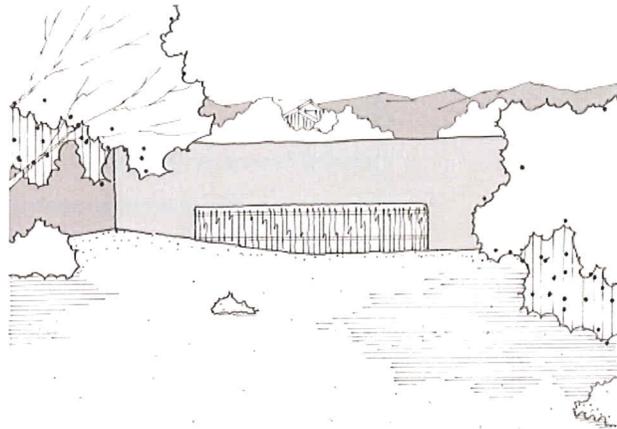
A wall shown with proper openings. Openings shall be sized for proper capacity by an Arizona registered Civil Engineer and approved by the Town Engineer.

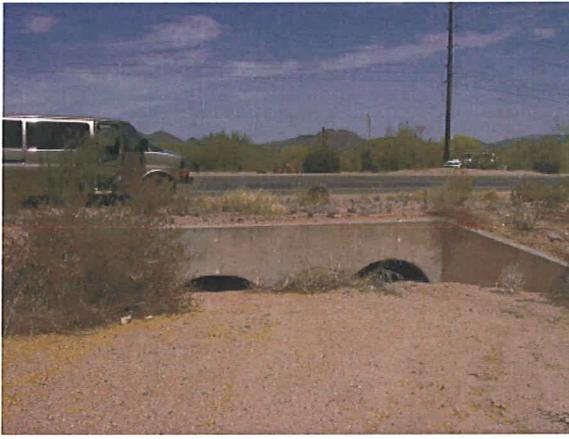
Sediment filled culvert.

Improvements to the culverts crossing Cave Creek Road at the UCT to Cave Creek, North and South Branches, are part of the recommended plan. The northern branch of the wash has been historically referred to as the Mormon Girl Wash. Currently, the culverts at both crossing locations are undersized and filled with sediment. Roadway flooding is expected during larger runoff events.

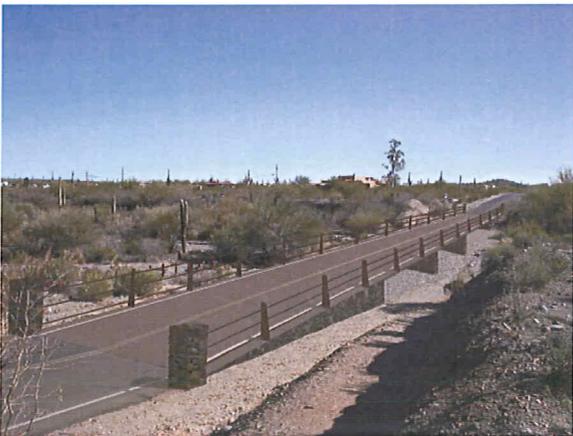
Figure 18: A simulated crossing in Cave Creek

All-weather crossings would be low profile, with rustic detailing and stone or dark colored concrete supports as suggested in *Figure 18*.

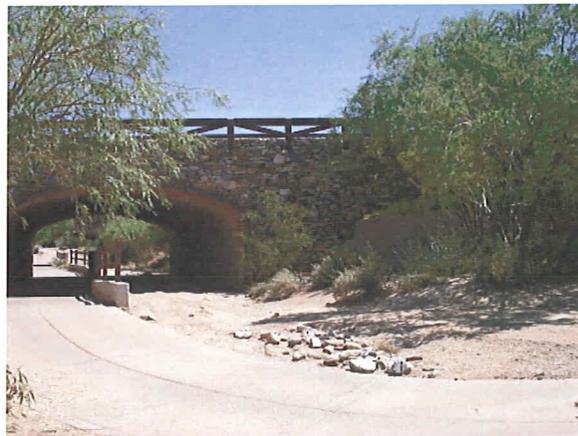
Figure 19: An all-weather crossing with rustic detailing

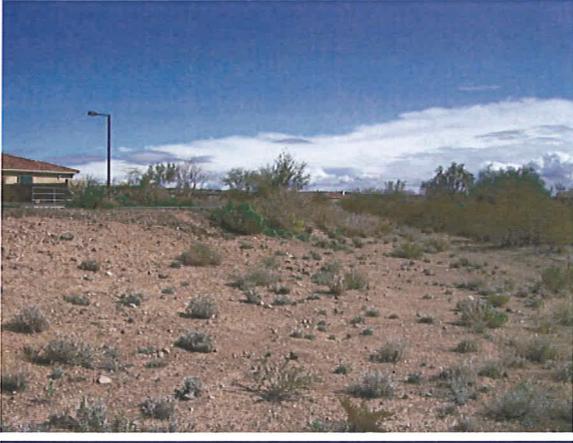
Figure 24: Buried bank protection after construction.

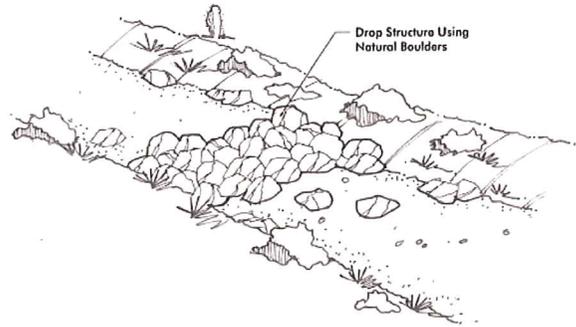
Figure 26. Grade control structure using on-site materials.

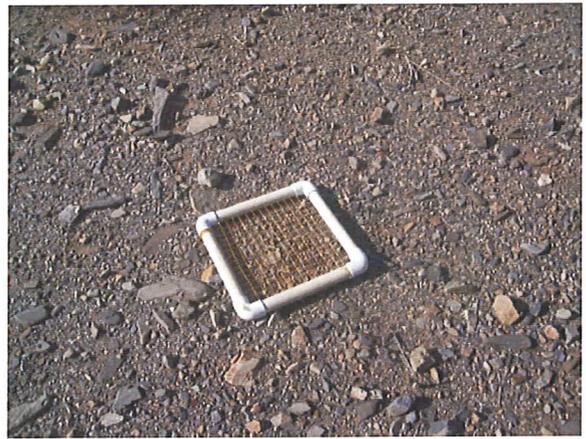
Figure 28: Natural desert paving

Grading should restore the topography to as close to natural contours as possible. Embankments, basins, and channels should meander so they feather into the landscape. Avoid paved embankments by providing 4:1 slopes that can be revegetated. Rock mulches or stone riprap also help to stabilize slopes and should have a random “desert paving” appearance (Figure 28), not the uniform, 2 inches of decomposed granite often used in commercial development.
